Faulty Condensers

Pressure Sensors Danfoss and Pumps Reich for CLIMACELL

Opening the VACUCELL device Door

BMT_PR_bulletin_servis_04_cz_4_2013

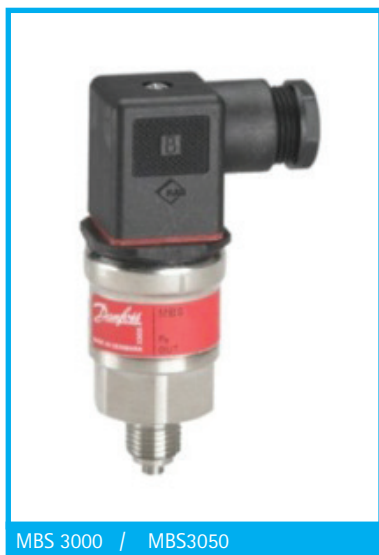
MBS 3000 / MBS3050

The pressure sensor by Danfoss is used for pressure regulation in the steam generator. There were some problems with the sensors in the past and we replaced them with a different type which should have eliminated the problems according to recommendations of the supplier – the company Danfoss. The sensors were subject to an expertise in the production plant and it was stated that the membrane of the sensor split. That is

why replaced the original sensor MBS 3000 with another one, the MBS 3050, in September 2012. The new sensor is equipped with a shock absorber – see figure. In fact, the shock absorber is a very small hole which is – due to operation – gradually clogged with small impurities and that is why the pressure sensor does not work correctly and it provides the control system with incorrect data. This may cause further damage of the generator. Now we return to the original pressure sensor as it proves that the problem with the cracking membrane was not caused by hydraulic shock. We have simultaneously performed a construction adjustment of the steam developer. The sensor function can be checked as follows:

0 bar..... 4 mA

1 bar..... 20 mA

In the course of time we detected that the problem occurred mainly in winter months. That means that water residuals freeze in the pressure sensor as well as in the submersible pump. That is why I would like to draw your attention to thorough drying of both of the parts in case that the device is to be operated in period when frost is expected. In case of pressure sensor it is not sufficient to simply let the water off the generator, but it is necessary to dismantle the generator and to suck off or shake out the condensed water in the chamber. We also recommend transporting with unscrewed drain plug so as to avoid under-pressure development in the generator. The Reich pumps must also be dried and it is necessary to drain water from all the other water-containing components.

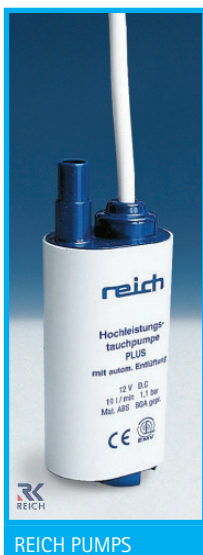
REICH PUMPS

Recently, several clients encountered problems with submersible pumps Reich. Similarly to pressure sensors, they were damaged immediately after delivery to the client.
